ASB-1054

Service Bulletin

Subject: AT-50 Mechanical Stability

Date: March 28, 1994

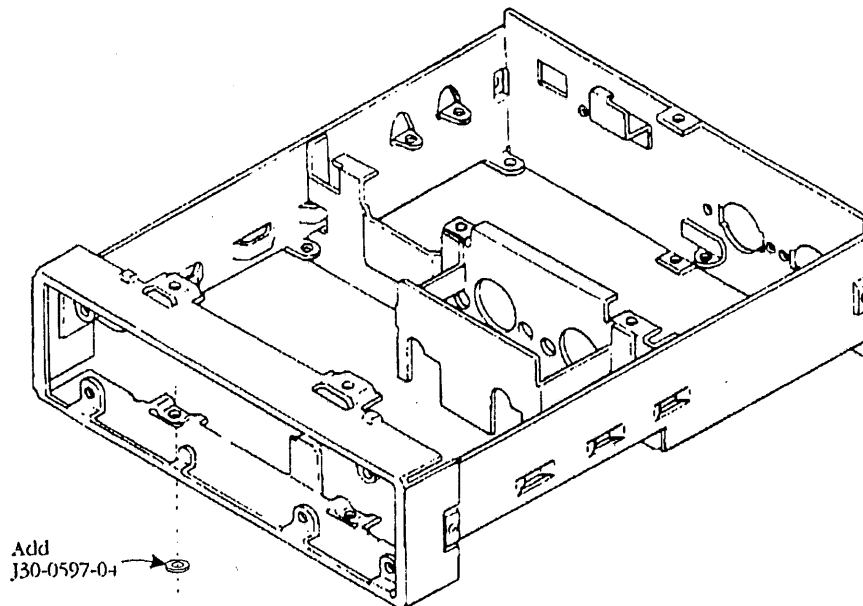
When the unit is placed on a flat surface it appears to be slightly unstable, i.e. rocks back and forth when pressing down on the left front corner of the unit.

Add a flat spacer at the location shown between the chassis and the bottom cover.
