ASB-1056

Service Bulletin

Subject: TM-732A/E APC Circuit Improvement
2006

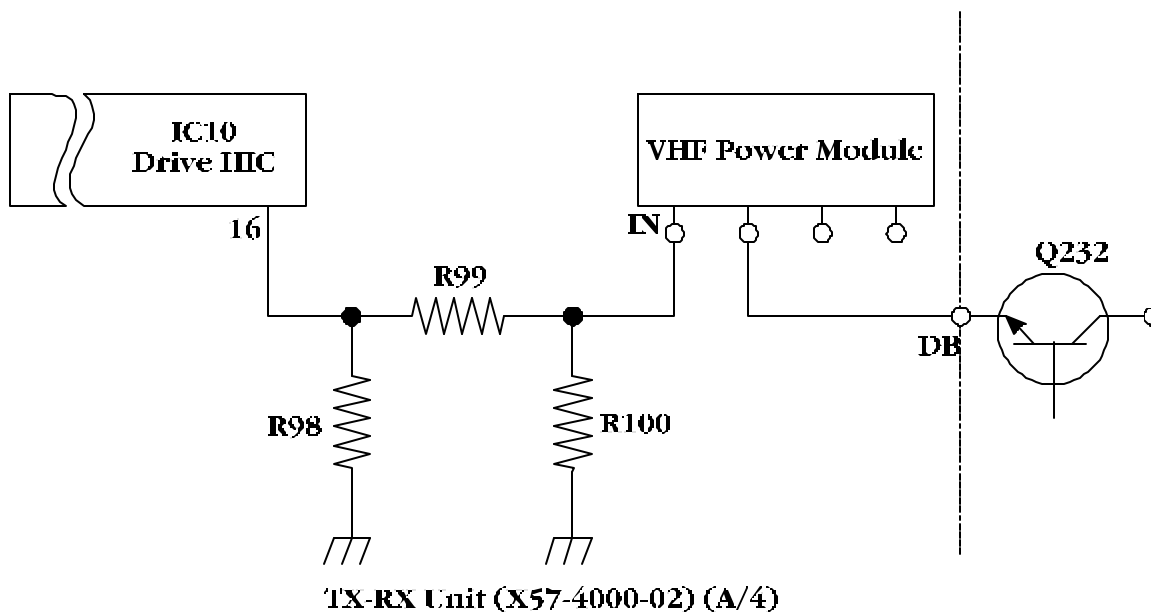
Failures of APC circuit transistor Q232 can occasionally be attributed to the gain dispersion characteristics of the VHF power module. Some of these devices allow normal transmit power output even with reduced "DB" terminal voltages. If the unit is then operated for extended transmit key down periods Q232 can overheat and fail.

1. Measure the transmit power output and the "DB" terminal voltage at a dial frequency of 145.020 MHz.
2. Add the 1 dB circuit if the transmitter power is 60 W or greater and the "DB" terminal voltage is 10 vdc or less.
3. After adding the attenuator, re-adjust the transmitter output power for 50 W and check the "DB" voltage. The "DB" voltage should now fall between 10 and 11 vdc. If it does not adjust the values for R98, R100, and R99 until this voltage range is obtained.

Pad Attenuation	R98, R100	R99
1 dB	820 ohm	5.6 ohm
2 dB	470 ohm	10 ohm
3 dB	270 ohm	18 ohm
