ASB-1058

## Service Bulletin

**Subject:** TM-455A/E Change in Pin Diode  
2006

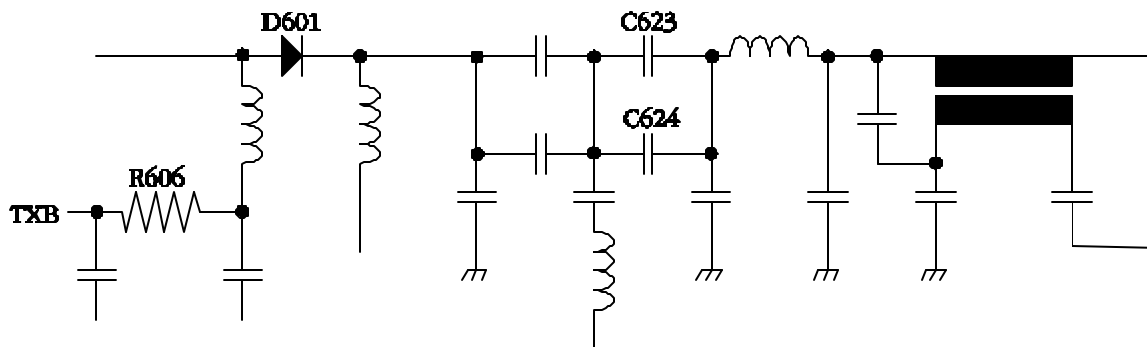
**TX-RX Unit (X57-4510-00 C/5)**

Some early versions of the TM-455A/E have been discovered with a bad solder connection at the final module pin diode, D601. If the impedance of this device is too low, the power consumption for this device goes up. This increased power consumption might cause excessive heating of the solder connections, and may result in a failure of the connection(s) after long FM transmissions.

On the TX/RX unit replace diode D601 with a UM9401, change R606 to 100 ohms, change C623 to 5 pF, and C624 to 12 pf. After replacing these parts, readjust the NULL and Protection circuit using the procedures provided in the Service Manual.
