KENWOOD

ASB-1060

Service Bulletin

Subject: TM-733A PL Tone Distortion
2006

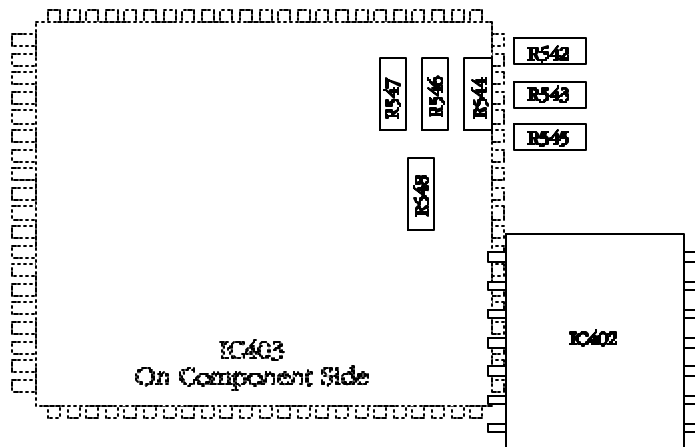
TX-RX Unit (X57-4360-00)
Foil Side View

Transmitted PL Tones at the receiving station have a relatively high level of distortion. This is easily seen when the incoming signal is viewed on an oscilloscope.

Change the value of the "Pull-up" resistors in the PL tone encoder circuit as shown in the accompanying chart and illustration. This reduces the distortion from around 9% to approximately 4%.

8. Turn the circuit board over and replace the resistors using the parts list and illustration as a guide.
9. Reverse steps 1-7 for reassembly.
