TS-2000X PLL Unlock Problems & Solution

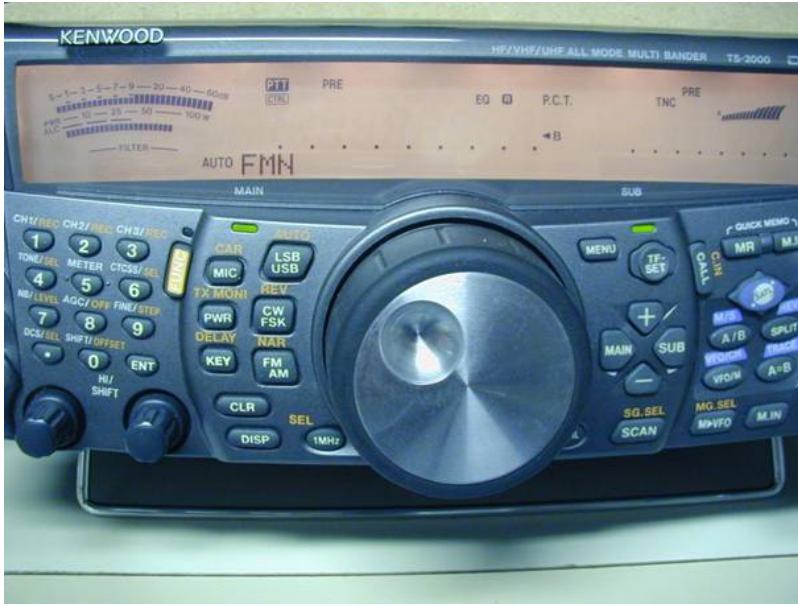
Several (yet not a lot!) users all over the world have reported PLL unlock problems with their TS-2000(X). Though in different conditions, all had the symptom that within seconds RF output power drops, and next the screen only shows a line of dots: instead of the frequencies in use, and the speaker announces in morse the report: "UL" (see also page 75 of the manual).

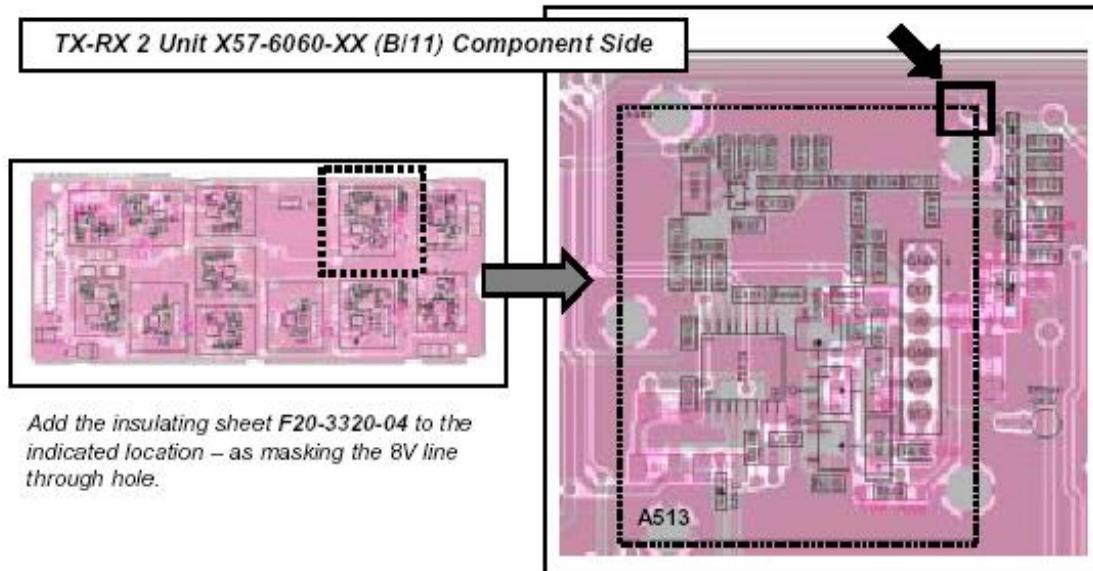
3. Another that the shield plate was hitting the positive supply point. Attached is a picture of the shield short probe. With your radio turning off that may be the problem. Even though it seems unlikely that a short like this can be intermittent, it can:

Add the insulating sheet F20-3320-04 as covering with the 8V line through hole.

Add the insulating sheet F20-3320-04 to the indicated location – as masking the 8V line through hole.

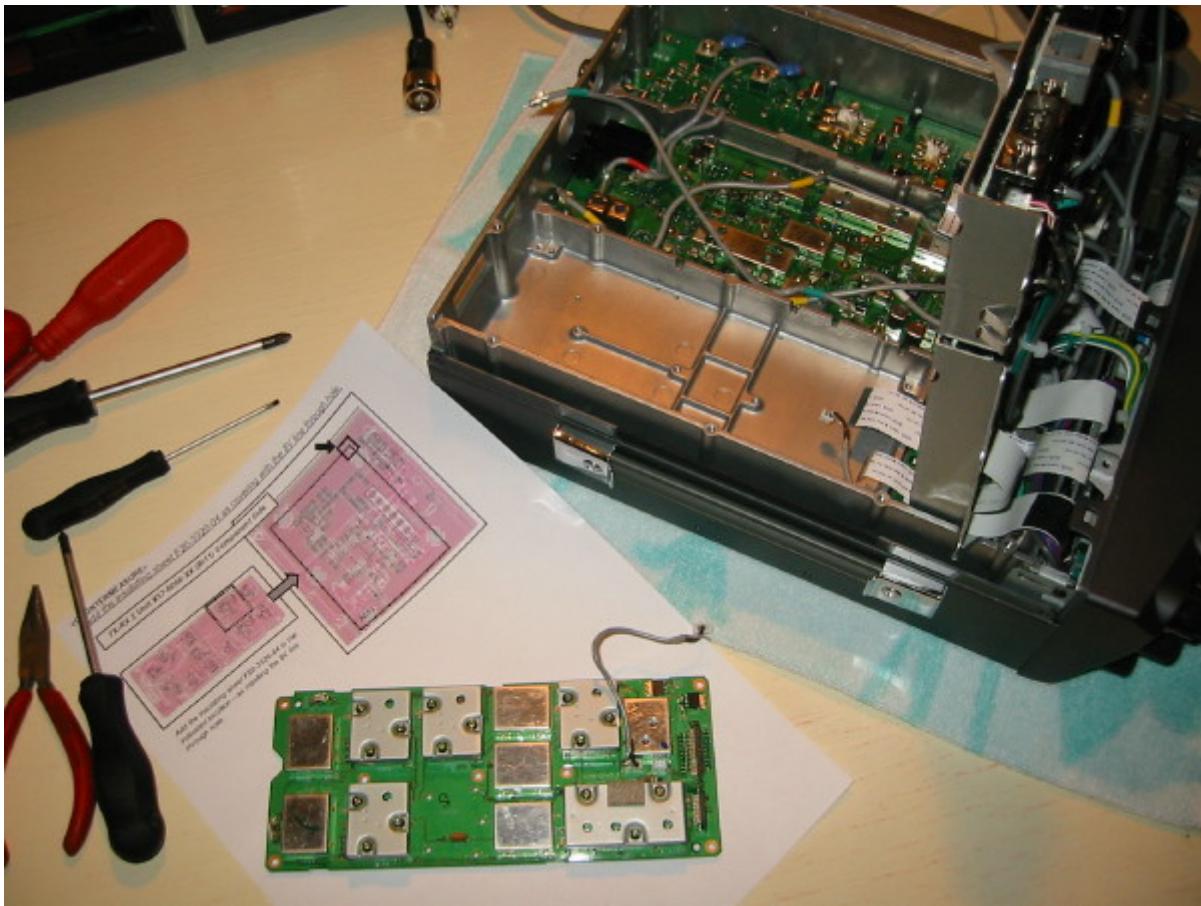
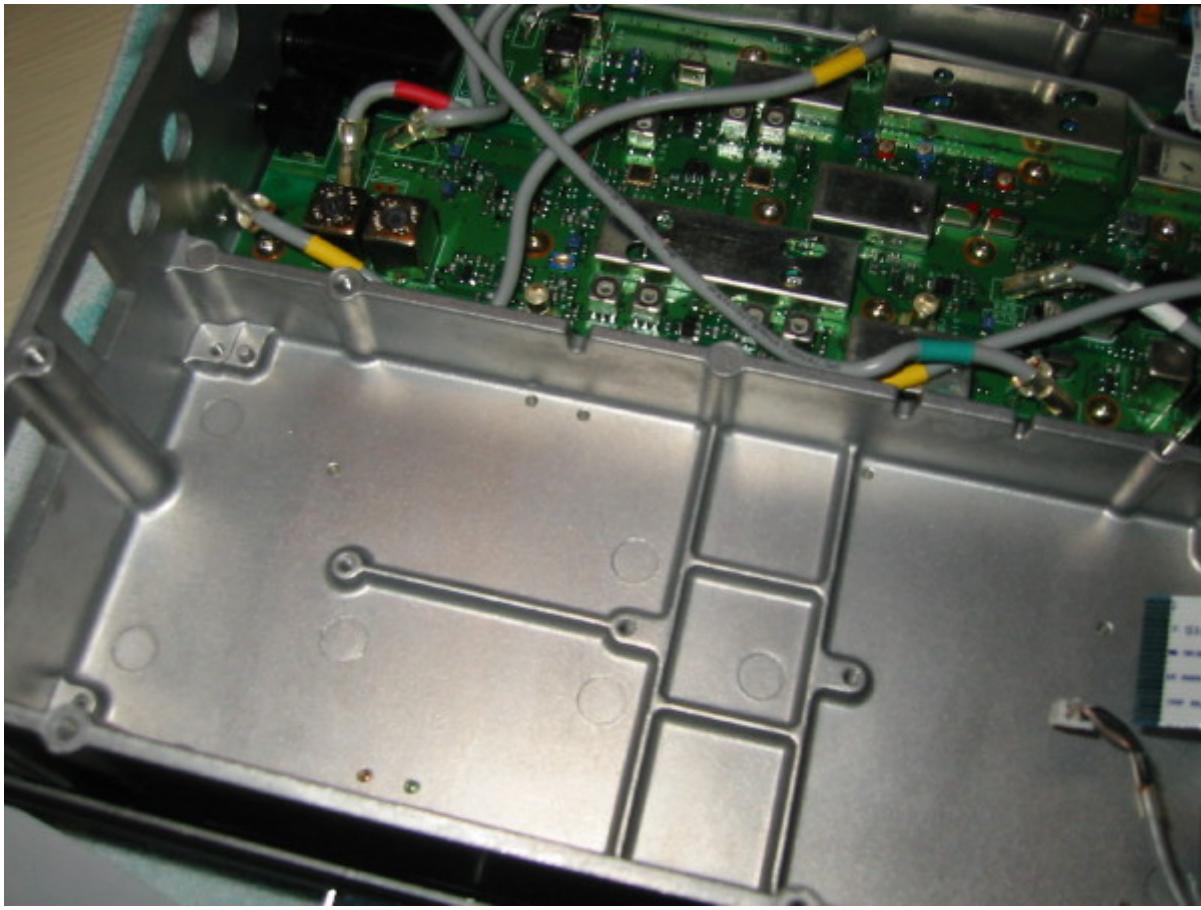
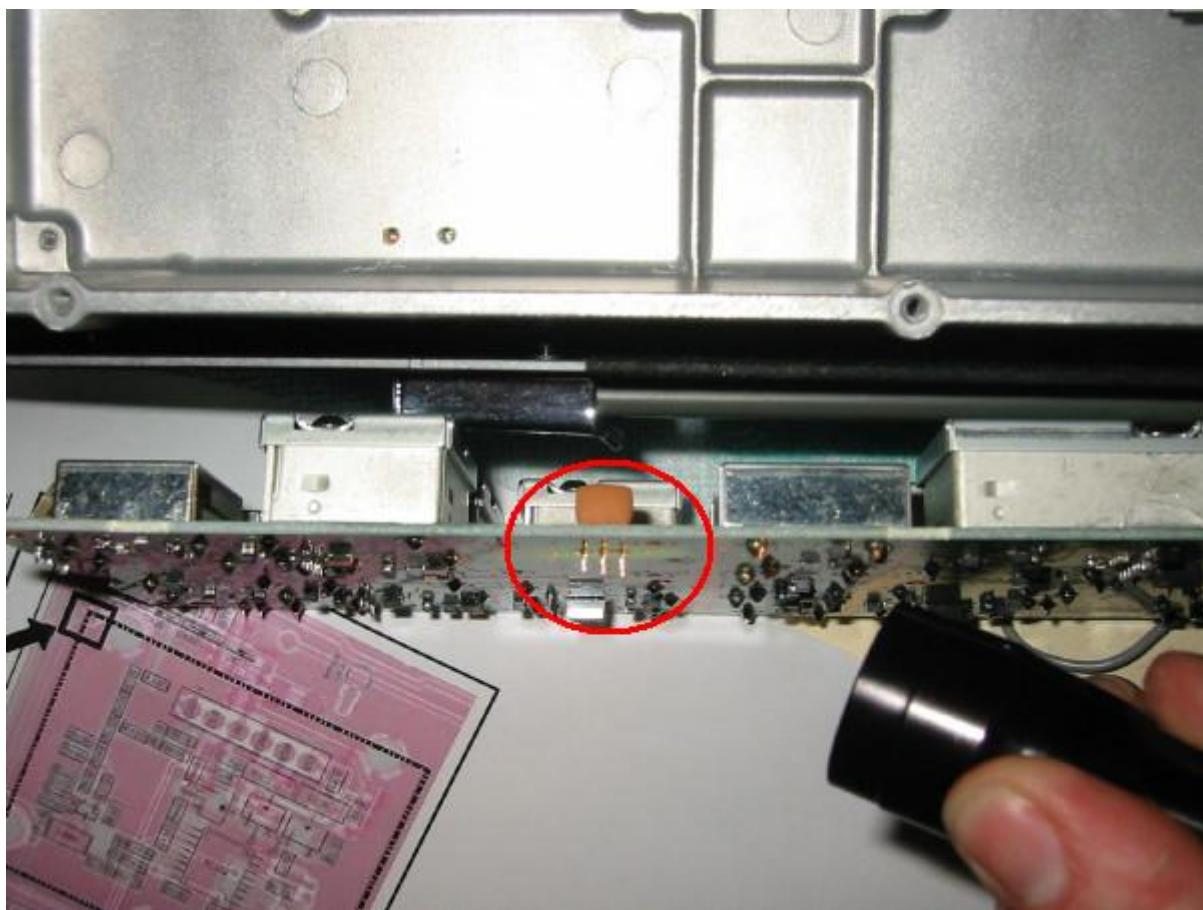
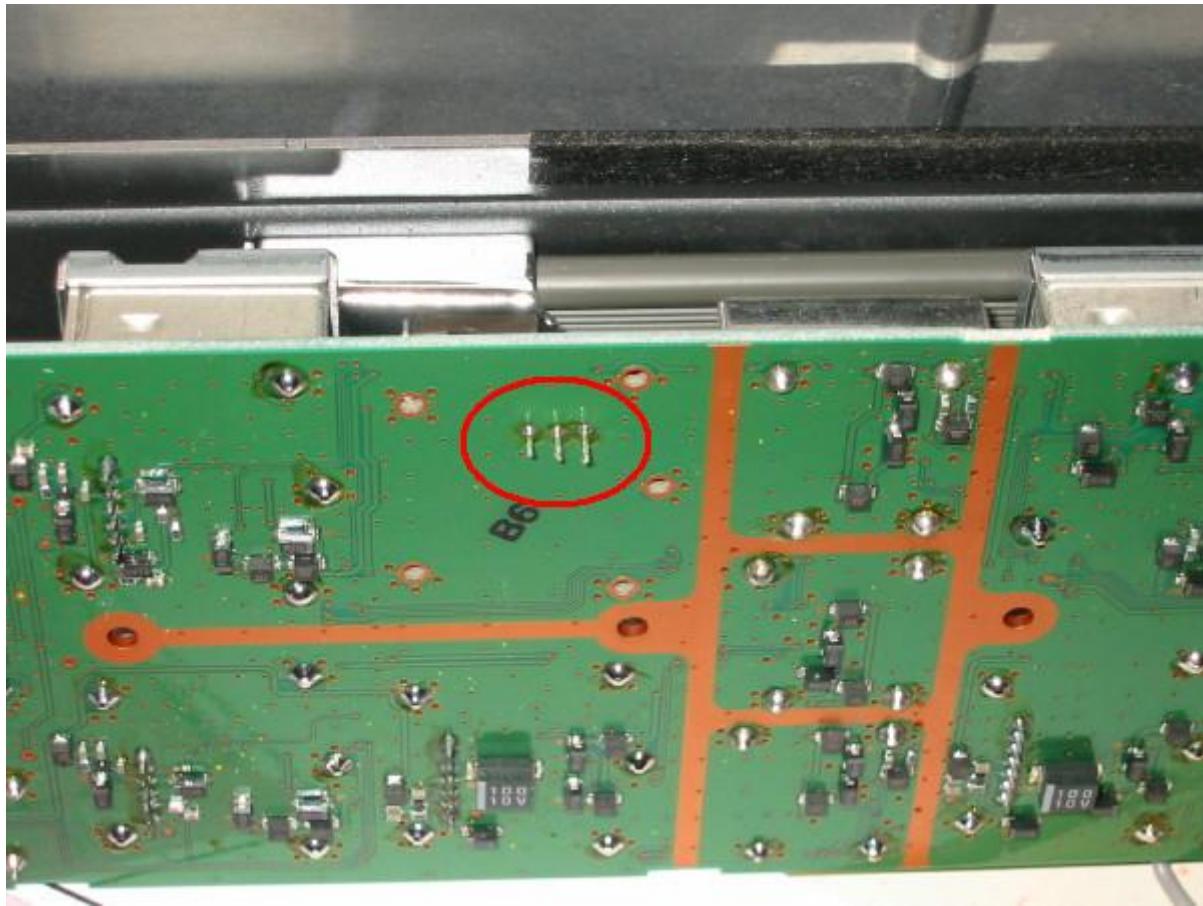
While inspecting the PLL / VCO PCB immediately we (PE1RXJ & PA3GUO) noticed the long leads of the ceramic filter that were not cut off properly (see red circle), and were very close to create a short between them and the chassis (ground). We have cut these leads back to an acceptable length.

More leads were present that were too long, eg the coax connector ones, and all were cut.

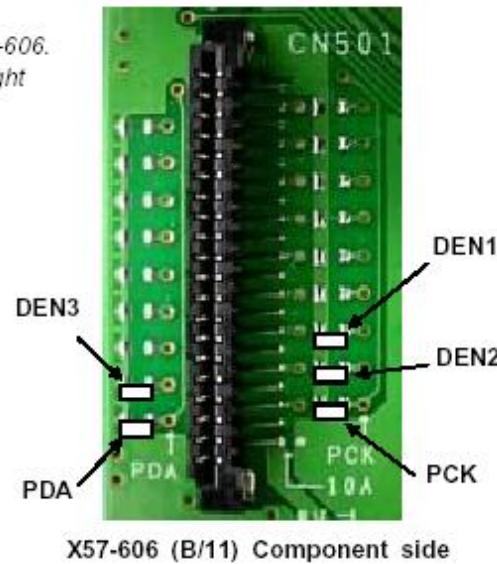
X57-606 (B/11) Component side

When the operating frequency of 430/440 MHz band is moved by main dial while transmitting, the PLL circuit of 430/440 MHz band is unlocked intermittently.

*The following 5 parts have been added to TX-RX2 unit X57-606.
There are spare lands beside CN501. Please refer to the right figure and attach the parts.*

Spare land name	Parts No.
PDA	CCT3GCH1H220J (22pF)
PCK	CCT3GCH1H220J (22pF)
DEN3	CCT3GCH1H220J (22pF)
DEN2	CCT3GCH1H220J (22pF)
DEN1	CCT3GCH1H220J (22pF)
