## HELP! I Just Got a TS-450/690

### Preventive Maintenance

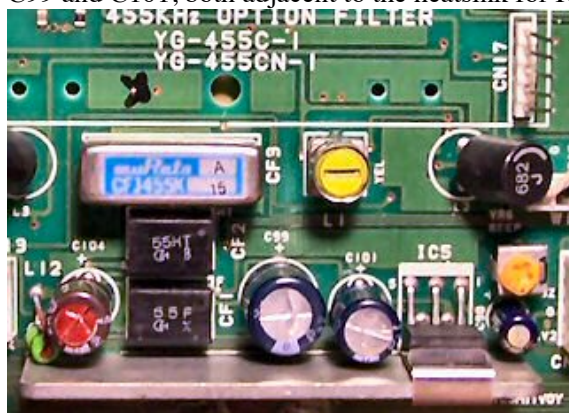
- I. Replace the battery on the CPU UNIT.
- II. Replace C104 on the IF UNIT. This capacitor often leaks.
- III. C99 and C101, both adjacent to the heatsink for IC5, may also need to be replaced.

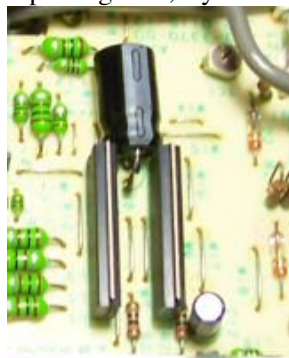
- IV. Replace C20 on the AT UNIT. This capacitor is sandwiched between the two motor drive ICs, IC4 and IC5. When replacing C20, lay new capacitor over away from motor drive ICs.

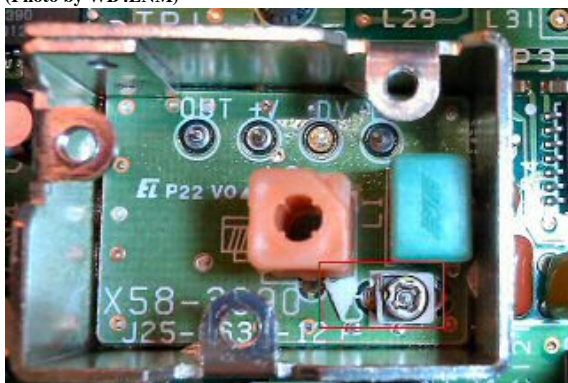
(Photo by WB4LNM)

1. If you are *lucky*, the cause of PLL unlock could be loss of HET Oscillator VCO2. Although I haven't seen this problem myself, John, WB4LNM, discovered this problem in the TS-450 at K4RY. In this case, TC1 in the VCO2 sub-unit of the PLL UNIT had broken causing the 64.22MHz VCO to lose lock. Clif, KA5IPF, says that a broken TC1 is common.

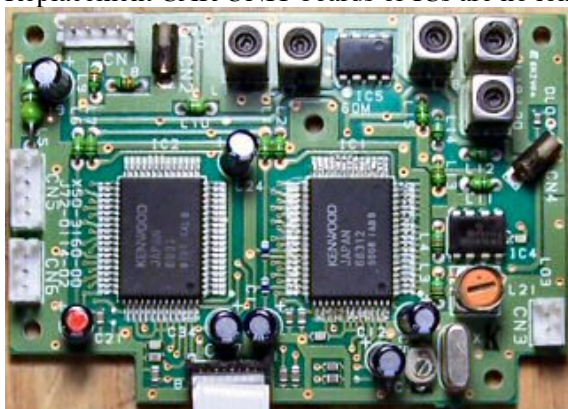
2. If you are *unlucky*, the cause of PLL unlock may be one or more bad DDS ICs, IC1 and IC2, on the CAR UNIT. Replacement CAR UNIT boards or ICs are no longer available.

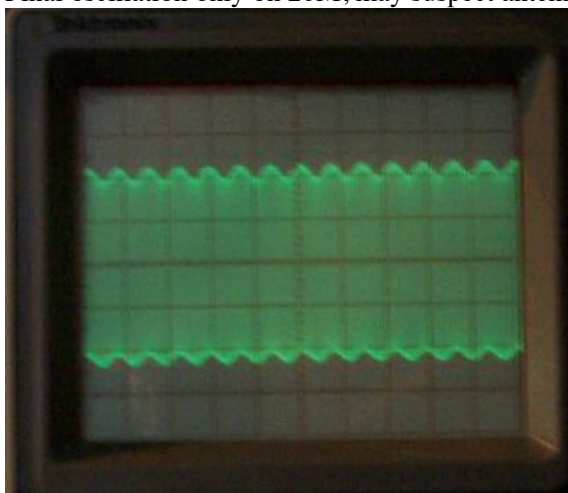
1. Final oscillation only on 20M, may suspect antenna tuner. Problem is really in final.

Scope timebase 1us/div. Oscillating about 1.5MHz(!) into dummy load on 20M, without tuner. Much worse with tuner.

2. Improve bypassing. Add 0.1uf bypass cap from L14, at center tap of output transformer L13, to ground. Scrape away resist near L14 for ground connection. New bypass cap should use short leads.
3. Lower resonant frequency of output circuit. Add 220pf caps across collector and emitter of final transistors as shown in Service Bulletin [ASB-1036/APU-0017](#).

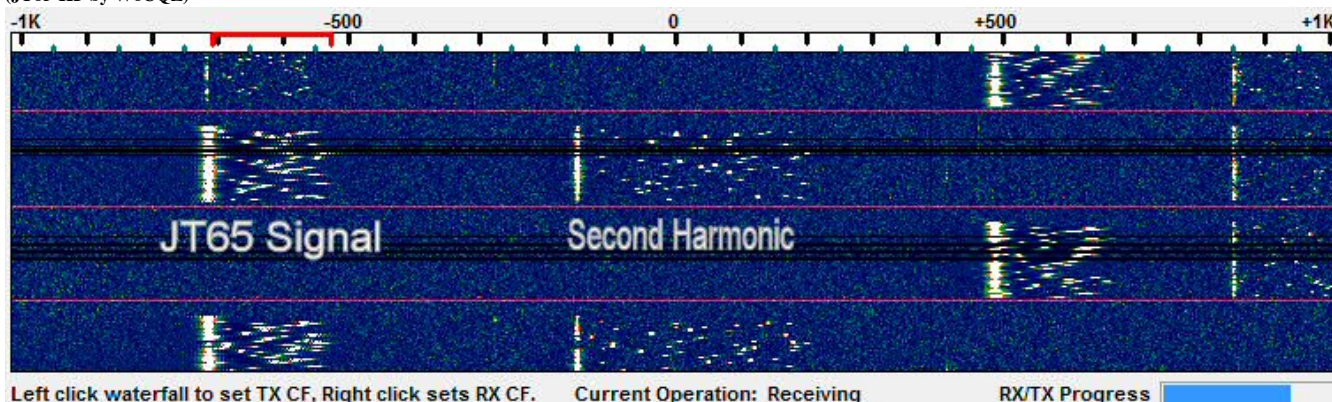
(JT65-HF by W6CQZ)

1. Packet receive output, J2, has unusually high level of distortion making output generally unusable for modern digital modes.

*These second order harmonics are generated in the receiver audio and are not a problem at the transmitting station.*

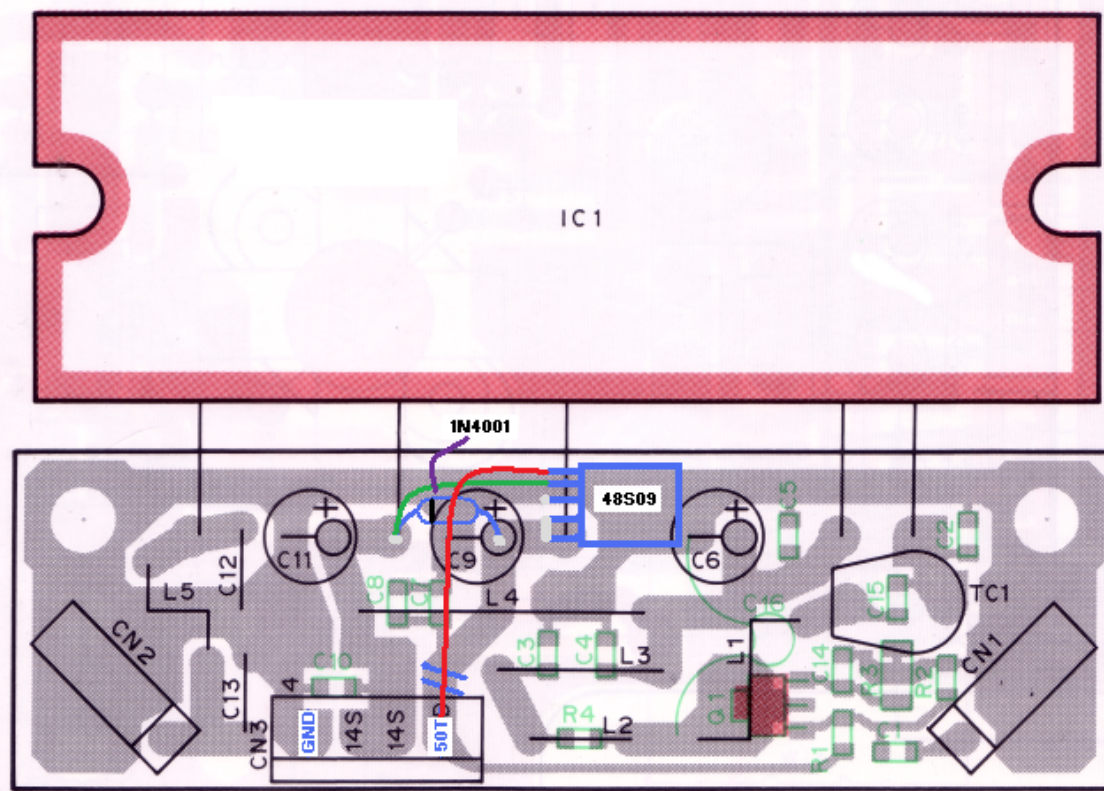
Foil side view : TS-690S

1. Erratic ALC after warm up, low drive on SSB caused by loss of gain in 6M driver, M57735.
2. Bias is 7V, should be 9V. When brick heats up, low bias voltage is insufficient to keep brick linear.

4. Use a Toshiba TA48S09AF SMD 9V regulator with ON/OFF and mount on foil side ground of driver board somewhere.
  - a. Cut 50T signal near CN3. Note corrected CN3 signals.

- b. Scrape away resist of ground foil and tin area between C6 and C9. The new regulator will be mounted there.
  - c. Scrape resist from ground near C9 and between C9 and bias pad. Tin these areas.

- d. Solder pin 3 to ground foil. Solder pins 4 and 5 to bias pad near C9. Solder IC flange to foil near ground lead of C6.
  - e. Add a wire from pin 1 to 50T at connector CN3. Note corrected signals names at CN3.

- f. Add a wire from pin 2 to 14S - use pad near C11.
  - g. A 1N4001 is added across the regulator for transient protection.
