## SERVICE BULLETIN Amateur Radio Division

TS-950S Final Amplifier Bias Circuit Change

January 23, 1992

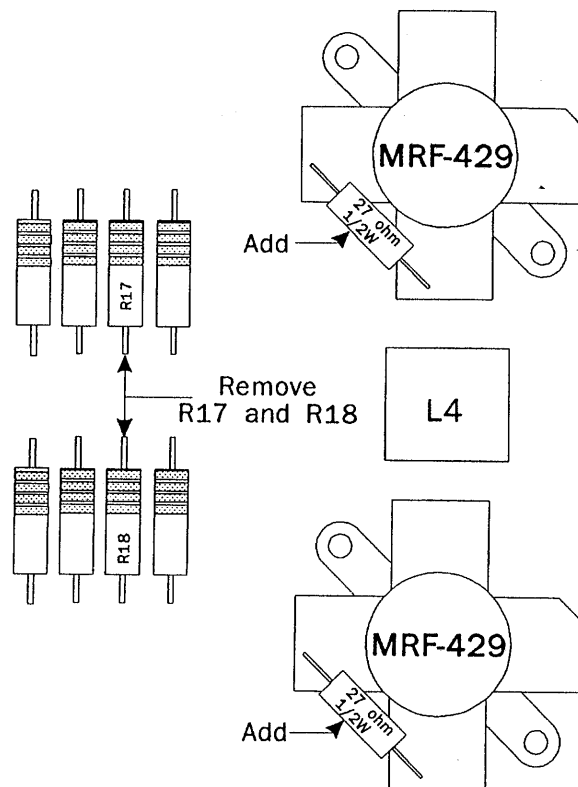
### Final Unit (X45-3330-00) Component Side View

R17 and R18 are carbon type resistors (27 ohms 1/2 w). Carbon resistors can emit quite a bit of smoke when overloaded in this manner and can be the cause of considerable concern by the operator!

1. The MRF-429 transistors generally fail one of two ways:
  - a) The collector/base junction opens. R17 and R18 are not damaged when this occurs.
  - b) If the MRF-429's are operated at RF power levels higher than the absolute maximum  $V_{cbo}$  rating the collector/base junction fails. This causes excessive current to flow thru the base circuit.
2. If the MRF-429's short collector to base with ceramic resistors there will be very little smoke before the resistor opens. The outward appearance of the resistors will not change, so you must make sure to check the resistors with an ohmmeter before installing new finals.
3. If R17 or R18 should open there will not be an appreciable change in the base circuit

In order to ease operator concern we recommend replacing R17, and R18 on the final unit (X45-3330-00) with ceramic resistors whenever replacing the final transistors. These special resistors have been designed to open quickly if the current rating is exceeded. This prevents smoking and the odors associated with burning resistors!

1. Replace the bad MRF-429 transistors.
2. Remove R17 and R18 from the component side of the Final circuit board.
3. Solder the ceramic resistors directly to the base and emitter of the final transistors. The stability of the circuit is improved by soldering R17 and R18 directly to the base and emitter of the finals. Do not install them in the old locations!
