SERVICE BULLETIN

from: TRIO-KENWOOD COMMUNICATIONS, INC.

No. 10

SUBJECT: Arcing in TR-7400A final section

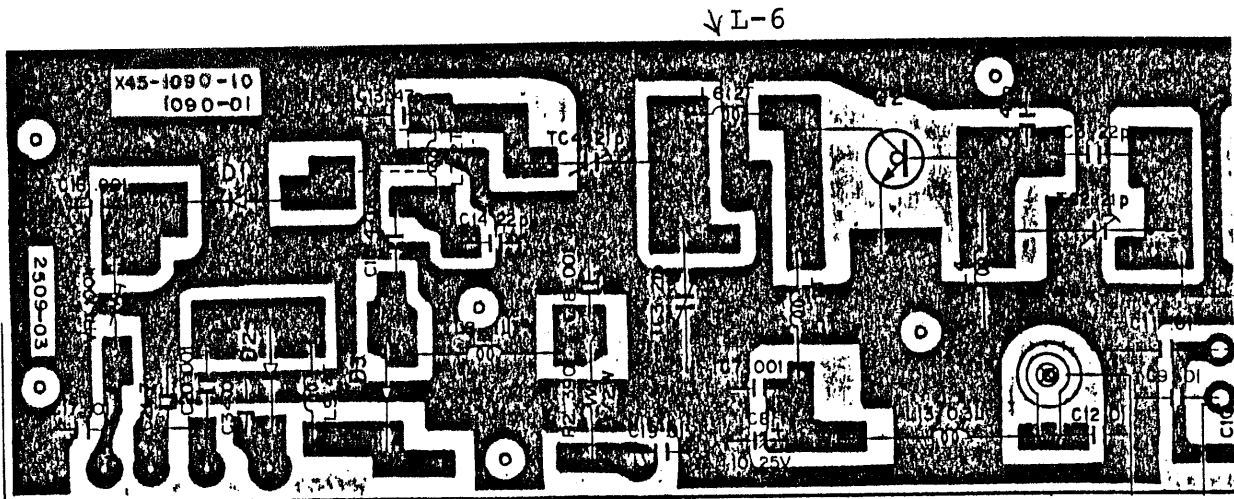
There may be some cases of arcing to ground beneath coil L-6 at the collector of Q-2 (2N6083) inside the final unit X45-1090-10. This is due to minute differences in the circuit board trace dimensions and a residue of flux on the board.

If this should occur, remove L-6 and clean all traces of carbon and flux from the circuit board. Resolder the edges of the tracer and remove any flux left from soldering. Modify L-6 as shown:

Reinstall L-6 and check for rated output. A slight retuning of TC-4 may be required.
