## SERVICE BULLETIN AMATEUR RADIO

SUBJECT TS-940S SSB TALK POWER IMPROVEMENT	DATE 7/22/87
---	-----------------

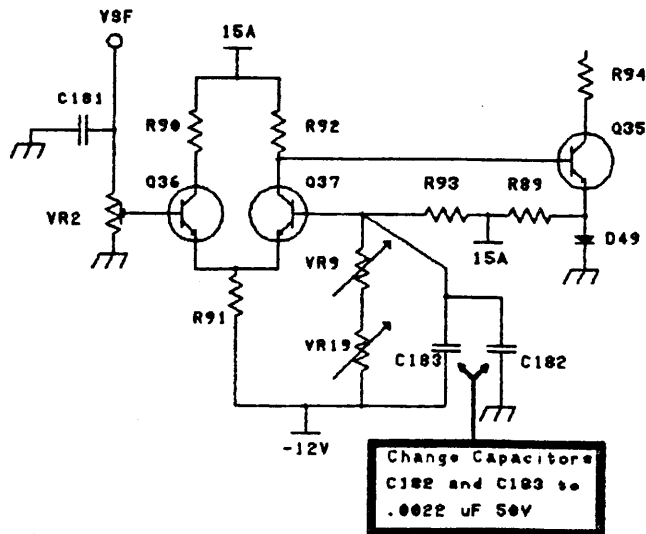
X53-1420-00  
Control Unit

TS-940S in the serial number range of 601xxxx through 708xxxx may be limited in SSB peak power as compared to full CW output. The level may be increased by changing the value of capacitors C182 and C183 in the ALC circuit on the Control board. The recommended replacement value for each capacitor is 0.0022 uF, 50V (PART # CK45B1H222K).

6. Carefully lift the board/heat sink from the right hand side and pivot it toward the front of the transceiver.
7. Replace C182 and C183 with 0.0022 uF, 50V capacitors (see figure 2 for PC board view).
