## HELP! I Just Got a TS-450/690

### Preventive Maintenance

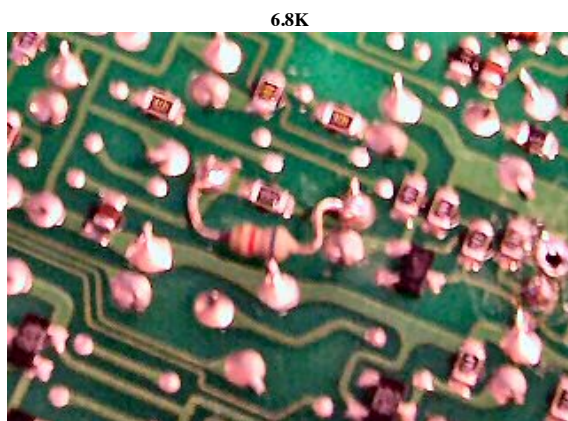
Schematic

2. Packet out amplifier, Q38, has no feedback. Add negative feedback and adjust input level to compensate for decreased gain.

Optical illusion, the resistor lead clears that adjacent pad.
