SERVICE BULLETIN

from: TRIO-KENWOOD COMMUNICATIONS, INC.

SUBJECT: ALTERNATOR WHINE, TR-7600/7625

DATE July 9, 1979

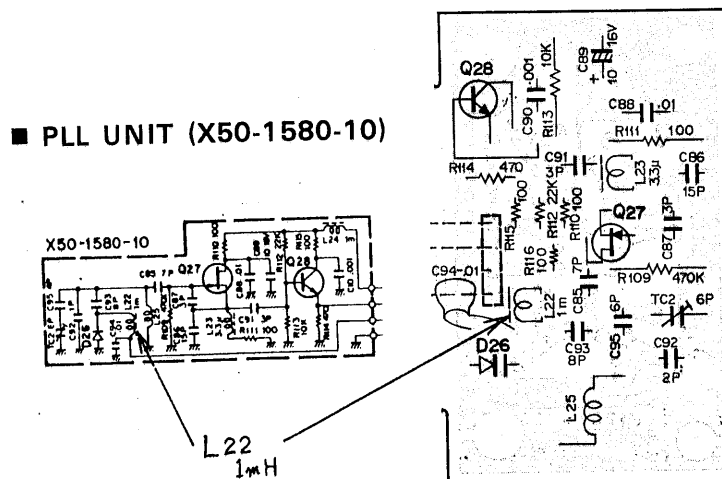
If all of these measures fail, replace L22 on the VCO unit X50-1580-10 from the original green coil, to either an orange or black coil. No adjustments should be necessary.

Old part number L40-1021-03 1mH
New Part number L40-1021-43 1mH
