SERVICE BULLETIN

from: TRIO-KENWOOD COMMUNICATIONS, INC.

SUBJECT: Feedback Between Pan Display and IF Out DATE: 7/25/78

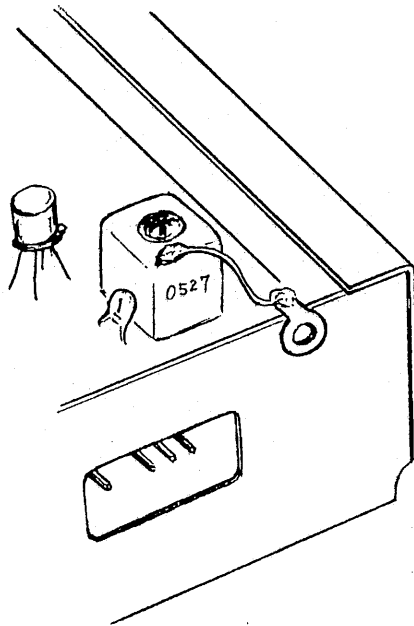
We have found a few cases of feedback when the pan display option was installed in the SM-220 Station Monitor. This is due to the isolated ground of the BS-5 or BS-8 pan display option. It may be remedied by grounding the case of the input transformer in the BS-5 or BS-8 to the case. (See drawing below.) This change will be incorporated in all future deliveries of the BS-5 and BS-8.
