SERVICE BULLETIN

TR-2400

#815

SUBJECT: TR-2400 PULSE NOISE

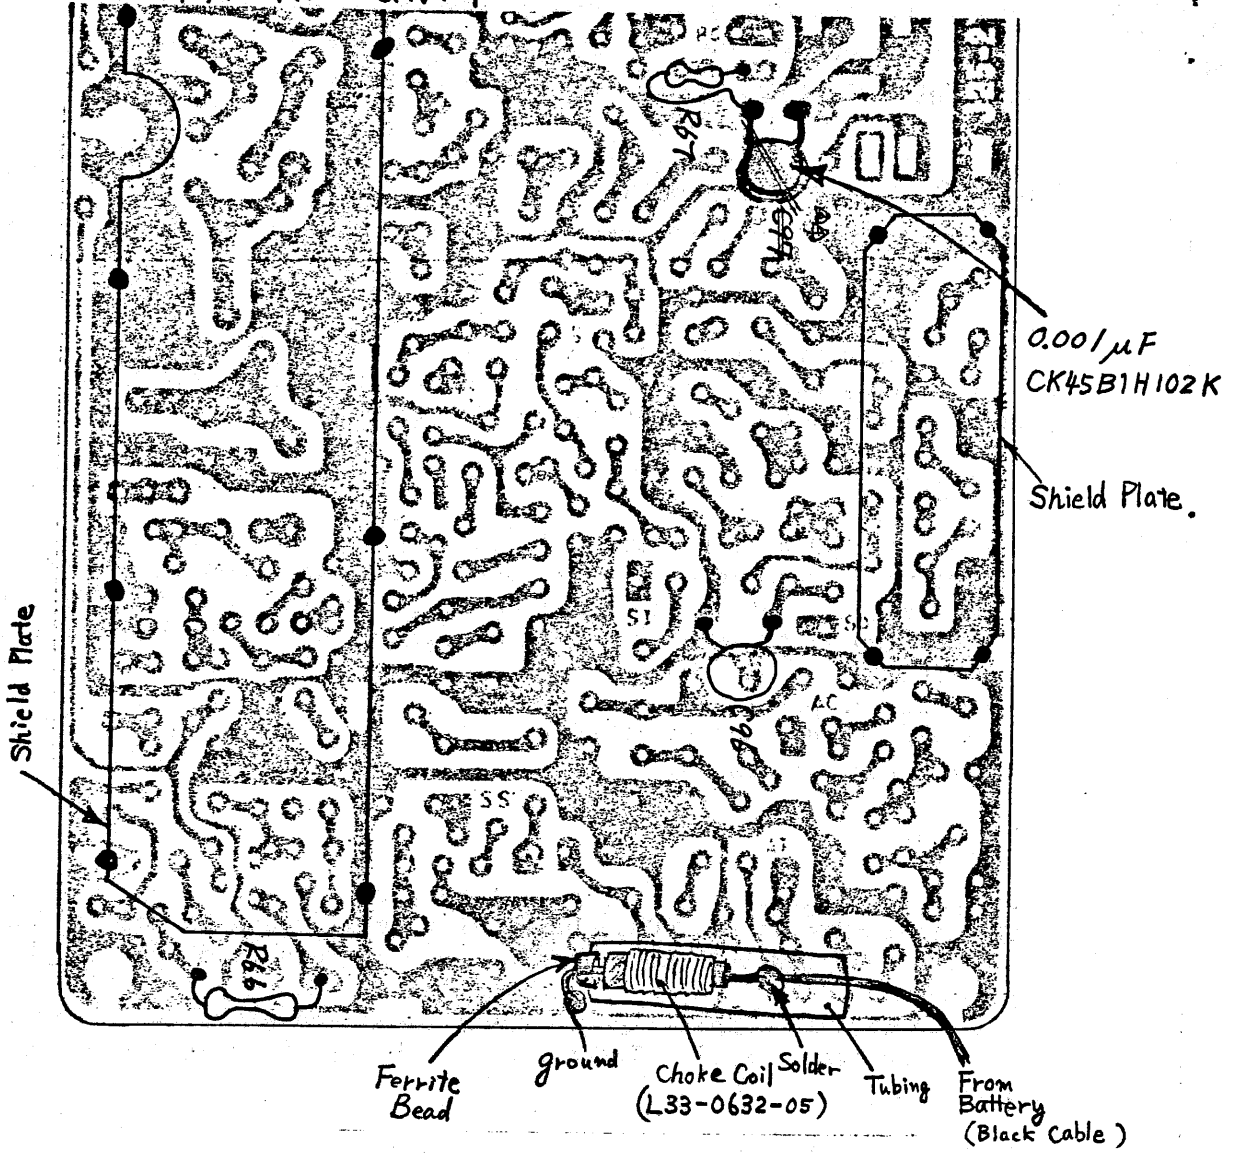
TX-RX UNIT

TX RF NOISE:

1. On the RX TX unit, locate the battery ground (BLACK) lead soldered to the right edge of the PCB. Desolder this line and install a choke with ferrite bead L33-0632-05 Resolder along the bottom edge of the board, as shown.
2. Also on the RX TX unit, locate the YELLOW lead attached to the foil side of the charge jack J1. Install a .001uF capacitor across J1 to ground as shown.

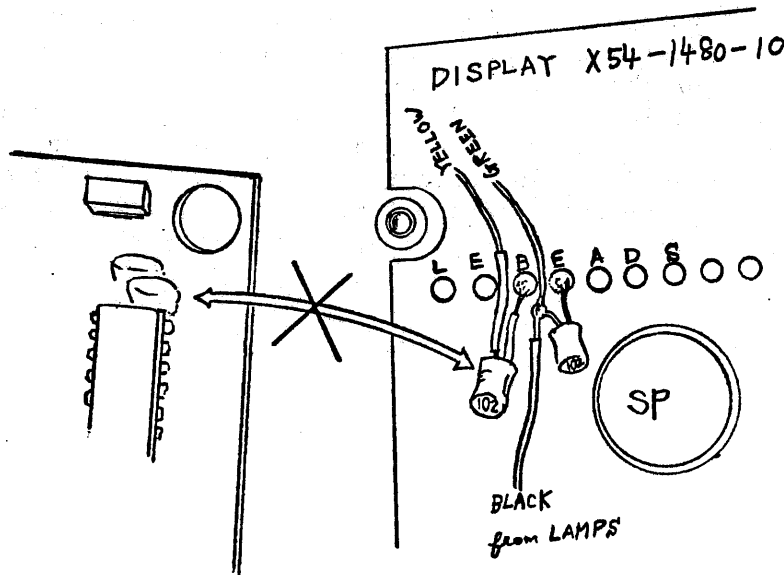
LED NOISE

TX OR RX LCD PULSE NOISE:

1. On the display unit X54-1480-10 locate the YELLOW lead marked B+. Desolder this lead and install a 1uH choke L40-1021-03 in series. Lead dress MUST be as shown for physical clearance.
2. Also on the Display unit, adjacent to the B+ lead, desolder the GREEN E (earth) lead and the BLACK E lead, and wire as shown to another 1uH choke, L40-1021-03. Again, observe physical parts placement for clearance.
3. For reassembly, reverse steps 5 through 1. If components were installed as specified, there will be no clearance problems.
