SERVICE BULLETIN AMATEUR RADIO

SUBJECT TH-205/215 PROTECTION FUSE REPLACEMENT

7/22/87

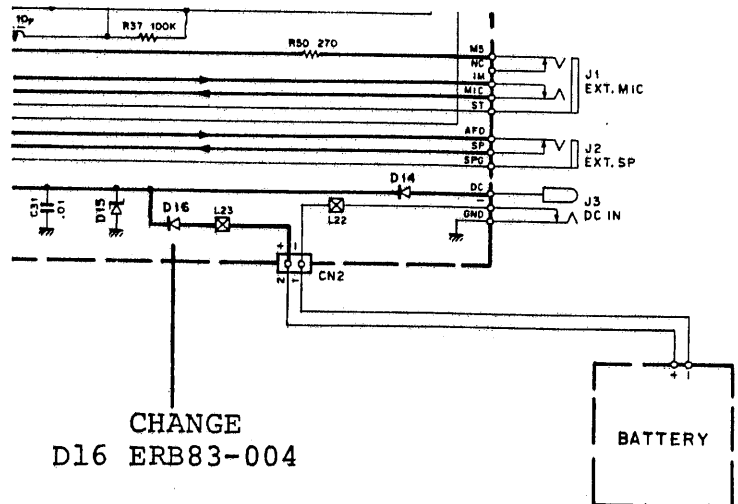
When a plug other than the PG-2V or PG-3C type is inserted into the DC IN jack, the ground side of the jack may not disconnect. This may cause the external DC power to be supplied directly to the internal battery which results in overheating the battery and blowing the fuse. To protect the battery, replace the fuse with a protection diode (Part # ERB83-004).

NOTE: Models with serial numbers greater than 801xxxx already incorporate the diode as D16.
