KENWOOD

SB-978

SERVICE BULLETIN AMATEUR RADIO

SUBJECT TH-75A INTERMITTENT MEMORY LOSS	DATE 08/08/90
--	------------------

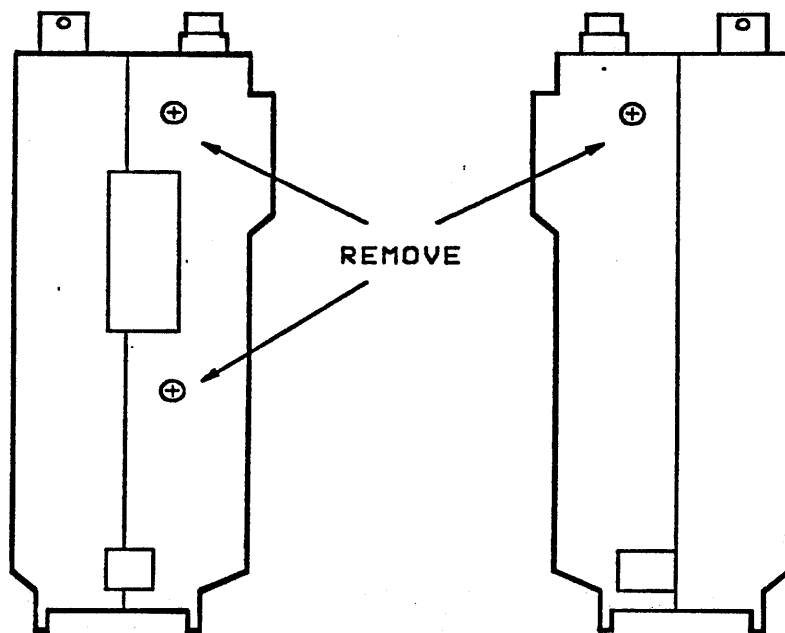
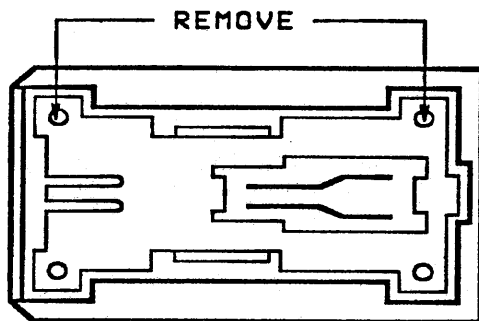
FIGURE 1

1. Disconnect the battery and antenna.
2. Remove the three case screws and two battery plate screws. **Figure 1**
3. Lift the front panel from the body of the transceiver and disconnect the two flex cables. To open the connectors push the tabs towards the flex cables and gently lift up. **Figure 2**

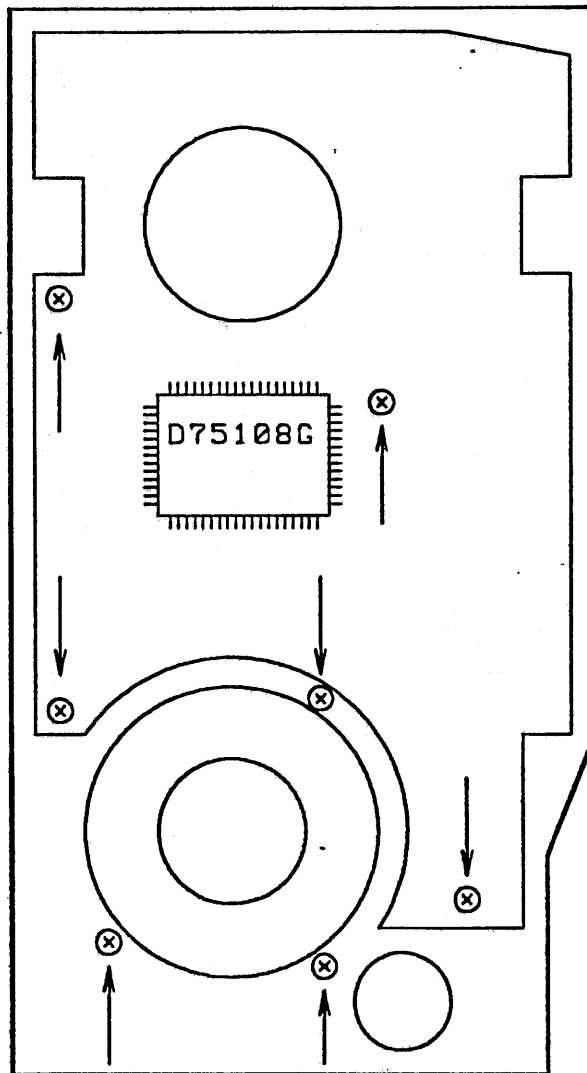
FIGURE 3

4. Remove the 4 screws from the Control board inside the front panel. **Figure 3**
5. Remove the 3 screws from the speaker mount. **Figure 3**
6. Carefully lift the Control board, PTT switch assembly, speaker, and mic element from the front panel. Do not break any wires.

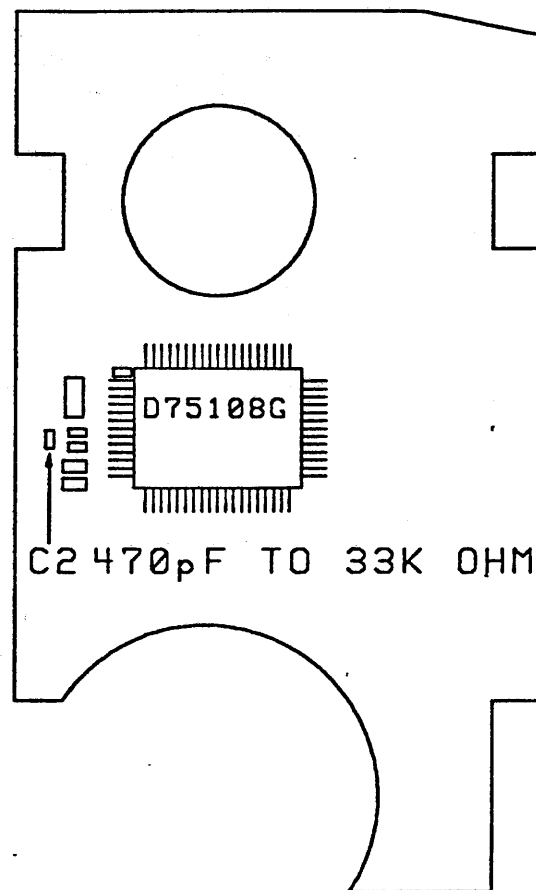
FIGURE 4

7. Lay the Control board on a soft cloth to avoid scratching the LCD.
8. Locate chip capacitor C2 on the Control board. **Figure 4**
9. Replace C2 with a 33K ohm chip resistor.

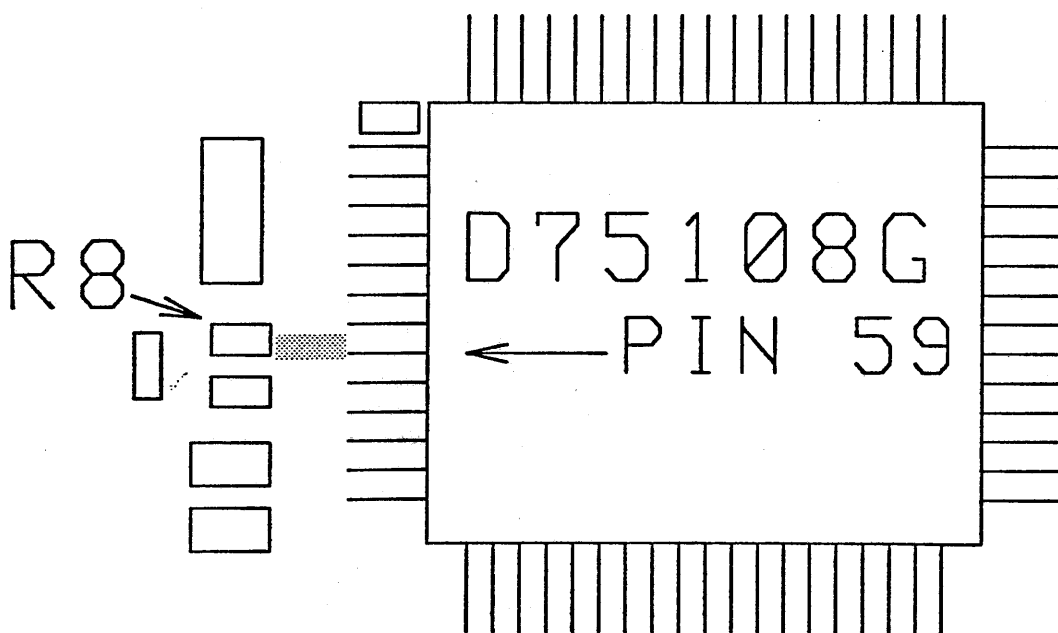
FIGURE 5

10. Remove the protective coating from the foil between pin 58 of the microprocessor and chip resistor R8. Presolder the exposed foil. **Figure 5**
11. Size, cut, and bend the leads of the 470pF ceramic disc capacitor and then install the component between pin 59 of the microprocessor and the ground side of the 33K ohm chip resistor. **Figure 6**

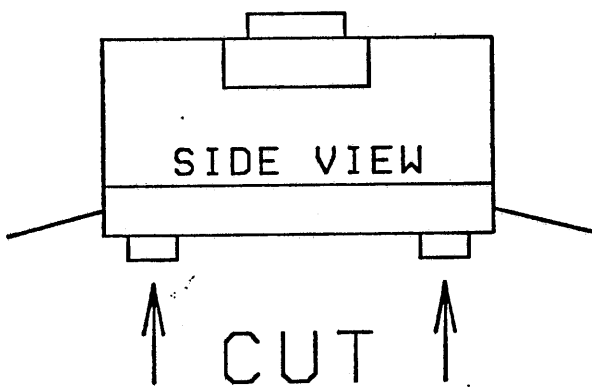
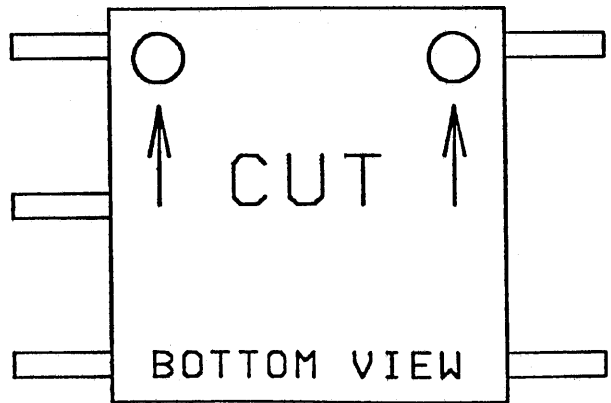
FIGURE 7

12. Remove the screw from the PTT switch assembly and then remove the rubber PTT cover from the board. Be careful not to lose the black plastic plate that fits inside the rubber cover.
13. Remove the PTT switch from the board.
14. Cut the tabs off the bottom of the new PTT switch to allow the switch to lay flush on the board. Figure 7
15. Install the PTT switch.
16. Assemble the transceiver.
