## SERVICE BULLETIN Amateur Radio Division

DSP-100 6-Pin Cable

January 26, 1992

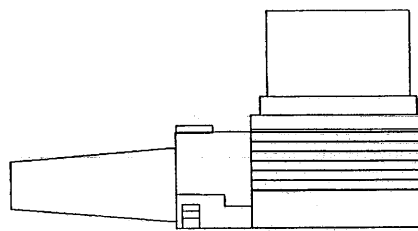
Difficulty might be encountered when connecting early versions of the DSP-100 to a TS-450S or TS-690S transceiver. No problems have been encountered with the TS-850S and the DSP-100. The length of the connector on the radio side of the cable might not be sufficient to ensure proper connection when connected to the TS-450 series. The connector has been changed on later versions of the DSP-100 to provide proper contact with these transceivers. The accompanying illustration shows the basic difference between the two cable assemblies. No problem should be encountered when using the new cable with any DSP-100 capable transceiver.

E30-3047-05  
Old Part Number

E30-3047-15  
New Part Number
