## Options for Repairing your Kenwood Power Amplifier

Rev. 1/08/2019 (Important note regarding Option 2)

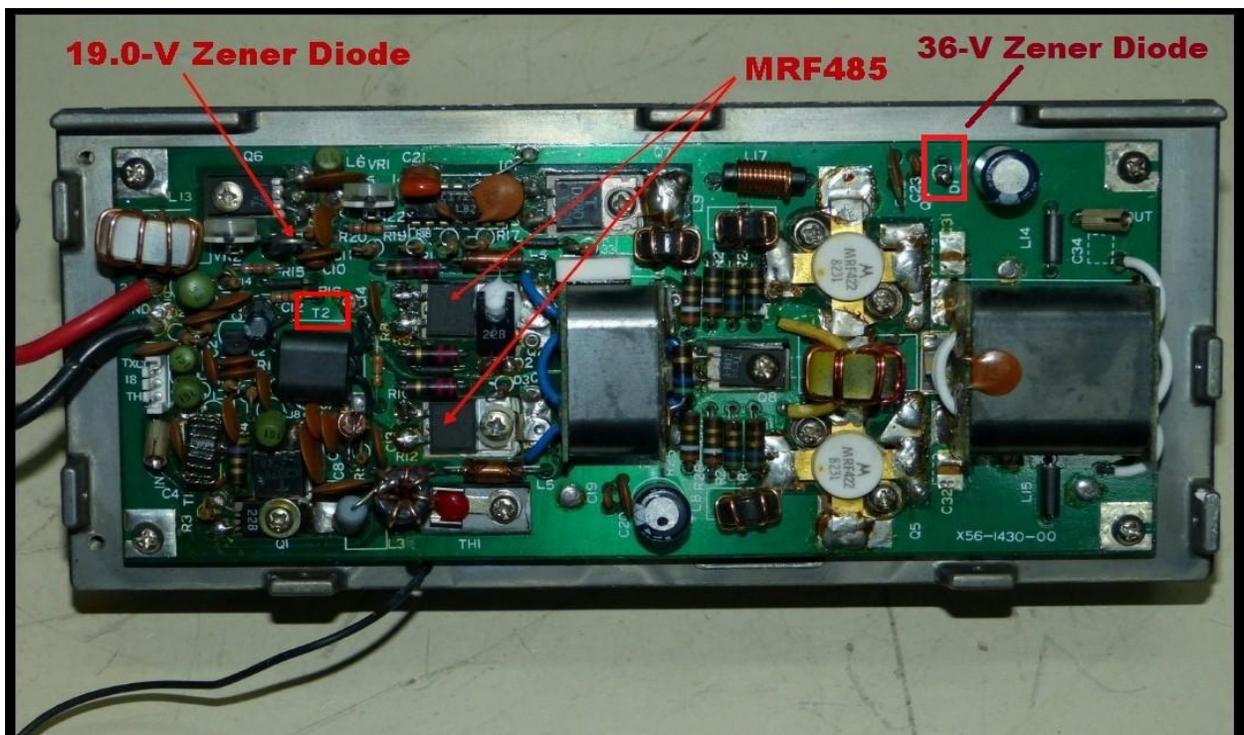
The picture below shows the locations of the components that are most likely to fail. From my experience, the drivers and Zener diodes are the only parts that blow when the OEM power supply fails. The drivers open, the diodes short. Since the Quint power supply has a maximum let-through voltage in failure mode of 32 volts, Zener diode D1 which clamps voltages over 36 volts, can be tossed. D5 is also optional. Both are intended to protect the PA from the over voltage from a blown OEM power supply, but they are inadequate. By the time they short, the damage is done.

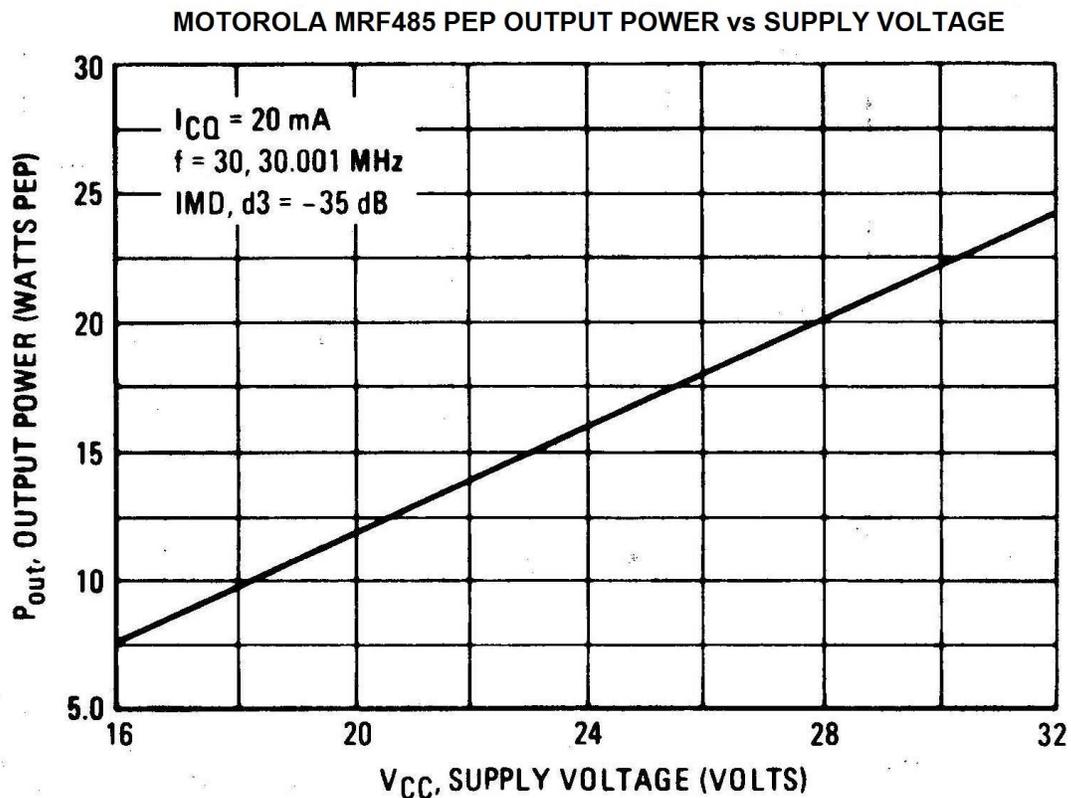
**THEORY OF OPERATION:** The Beta (hFe) is the DC current gain at a certain temperature, current and collector bias. While I have been unable to locate a graph of Beta vs supply voltage, I did find the one below, which shows the supply voltage vs output power in PEP watts of a Motorola MRF485. Note that at 28 volts bias, the graph shows a PEP power output of 20 watts (about equal to the 14 watts RMS shown in the MRF485 data sheet). At 16 volts, it's down to 7.5 watts. I tested the Eleflow MRF485's at 12 and 16 volts. Since the PA performed admirably with a driver supply voltage of 12 volts, and 3-amp, 12-volt regulators are easy to obtain, I settled on that option.

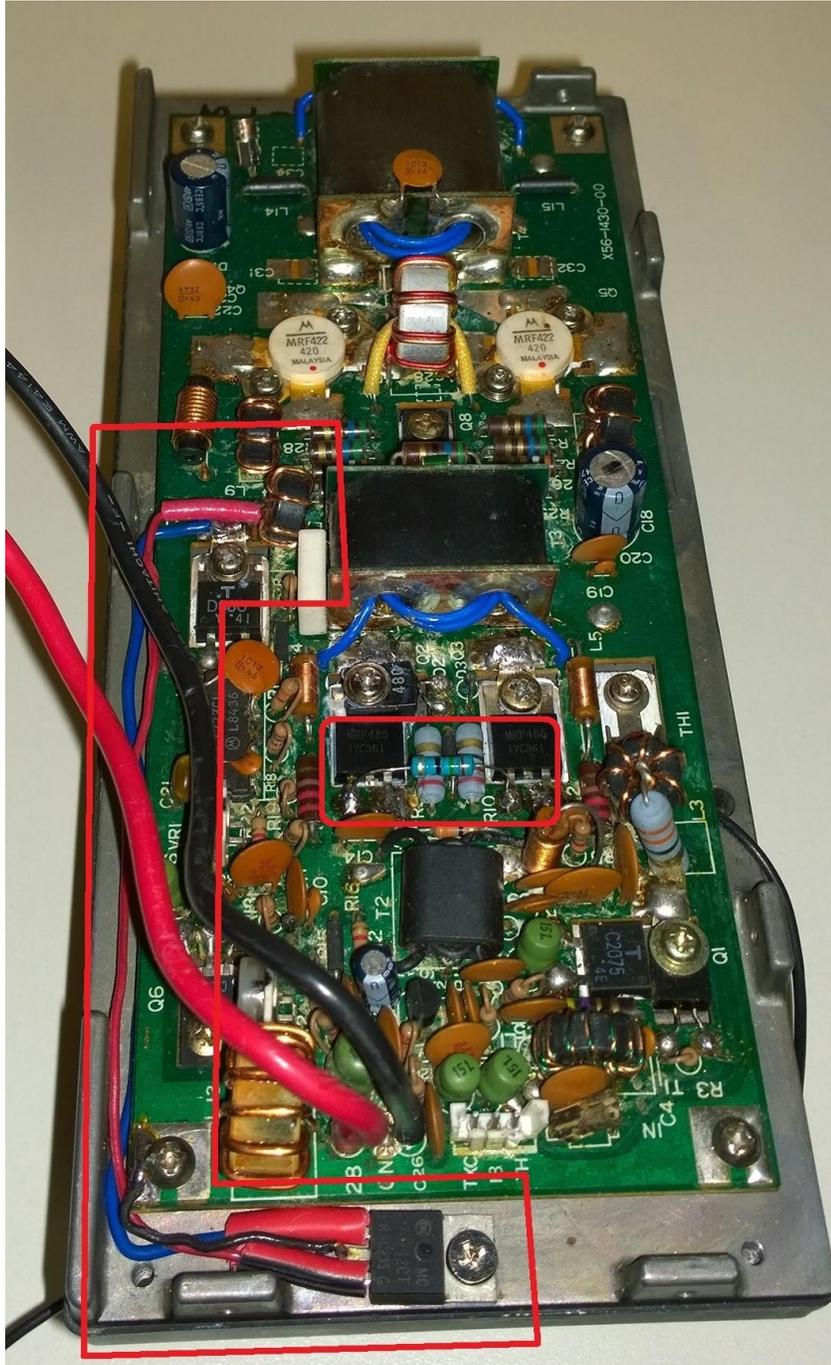
The black wire to the center ground terminal of the voltage regulator is not really necessary, but I put it in to be safe. The blue wire to the input terminal of the regulator is connected to the 28-volt tab where RF choke L7 was once soldered. The red wire carries 12-volts back from the 3-amp regulator to the collectors of both drivers via the end of L7. I used 1-inch pieces of insulation to protect against shorts but heat shrink tubing also works, and I used red and blue solid conductor wire to keep track of what goes where.

Here's a photo of the changes, with the areas where I made changes boxed in red. The screw used to secure the voltage regulator came with a computer hard drive kit, or you could take one of the fan screws from your 930S to the hardware store and find a short match. I would get a couple. The 15-ohm shunt for R8 can be simply soldered across the base tabs of the 485 drivers.

The advantage to this option is that you can do the work without removing the circuit board from the heatsink  
**NOTE: I would only use this option if you are sure that your board is in excellent condition on the foil side** (see new Appendix section). . . **A disadvantage to this Option is that the original feedback loops in the driver circuit are left unchanged, resulting in a PA that can be very "hot" on 10M.** The extent of this problem will depend upon the current gain of the MRF485's that you use, but the ones in mine tested in the 50-55 range, and mine pins the Ic needle on 10M unless I reduce the carrier control or adjust the MIC level so that the ALC remains in the red zone on the meter. Operation at such a high current level can cause spurious emissions and may damage your PA. At the very least, it will blow the PA fuse. Still, some HAMS prefer not to tear everything apart, and this option appears to be stable at frequencies below 25MHz.

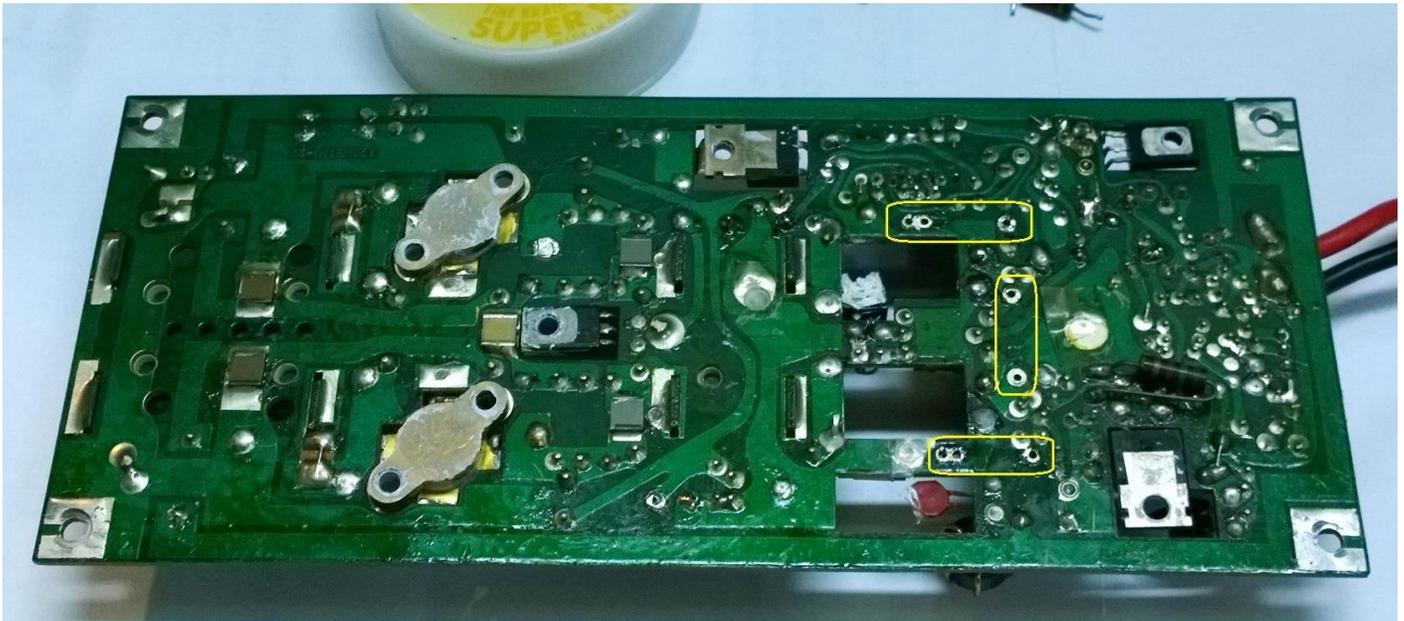
This photo shows a PA board with the three resistors – R8, R11, and R12 – removed, and the areas highlighted in yellow. Solder wick does an excellent job of assisting with the removal of the old solder and components.

This option reduces the Base-to-Base shunt resistor R8 that is across the secondary of T2 from 33 to 10 ohms, and halves the value of the 220-ohm collector-base negative feedback resistors R11 and R12 to 110 ohms. I used 100-ohm resistors for R11 and R12, and they work great. In fact, I recommend using them as an extra margin of safety.

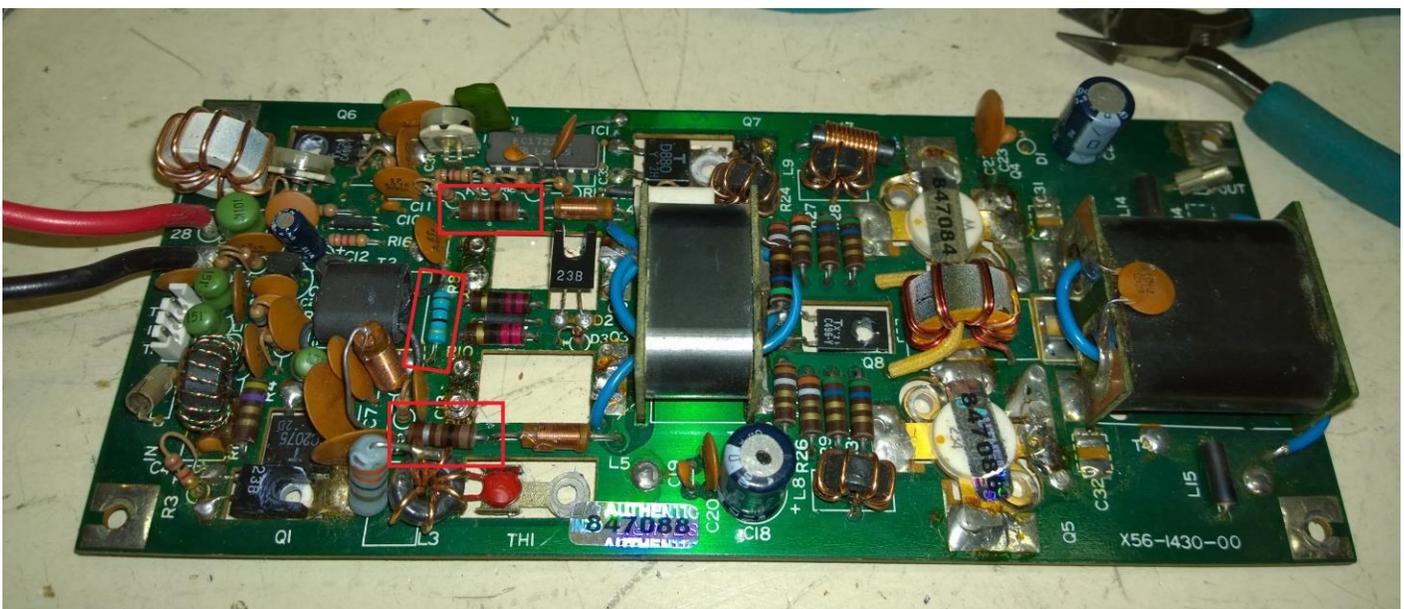
The photo below shows the finished PA board, with the new resistors outlined in red.

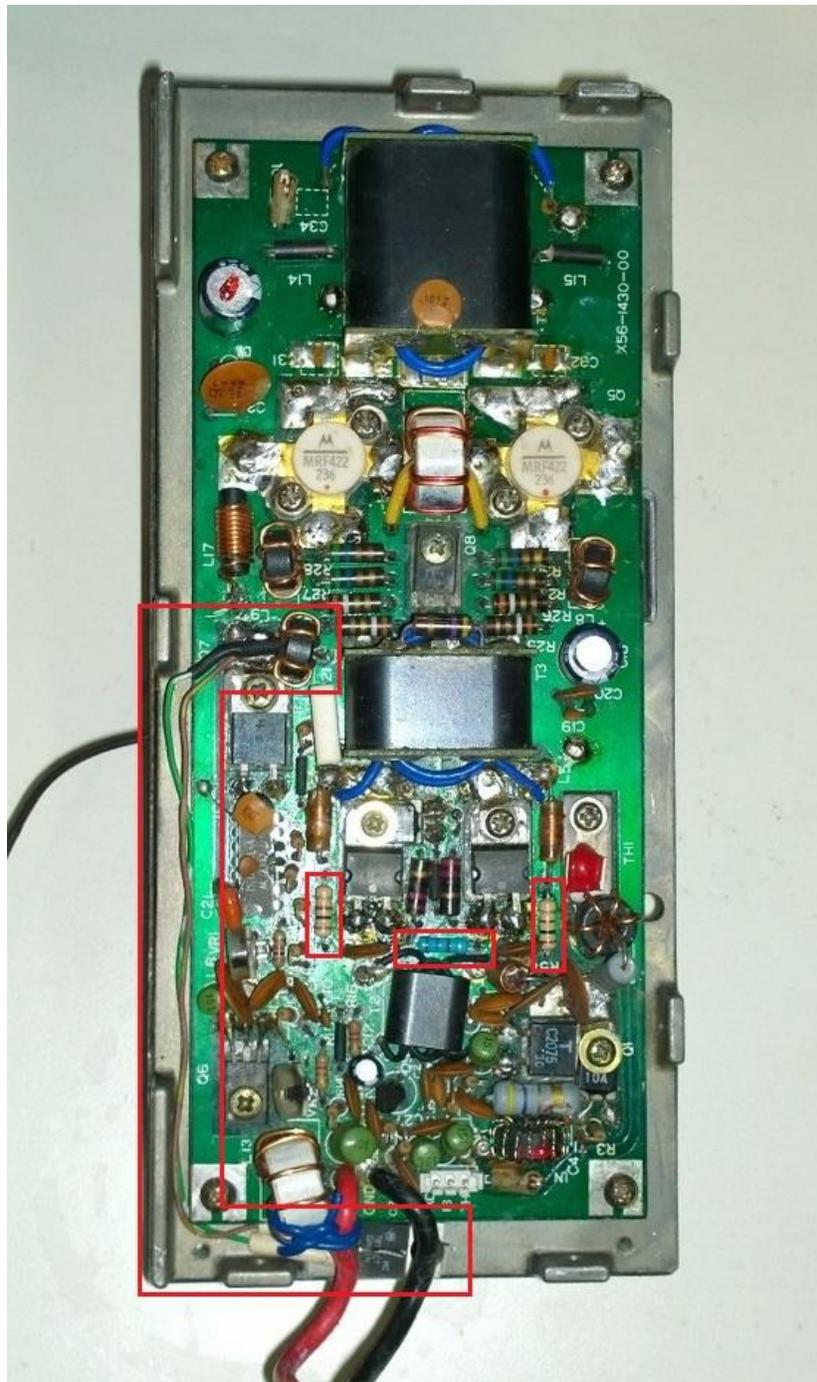
This photo shows the PA board with the areas where parts were changed highlighted in red. Obviously, the drivers were also changed. **I have one of these PA's, and it's stable at all frequencies, even above 28MHz.**

This option allows the use of high-gain drivers like the 2SC1969 by reducing the supply voltage, and adding the negative feedback loop changes described in option 3. This isn't unusual – I've seen at least two 930S PA's that used a 12-volt regulator combined with a pair of 2SC1969's, and at least one on an auction site offered a 30-day warranty. But the one that came with my "test bed" 930S had one blown MRF422 "pill". This was a first for me, and I suspect the 422 blew because simply reducing the voltage to the much hotter 1969's was not enough.

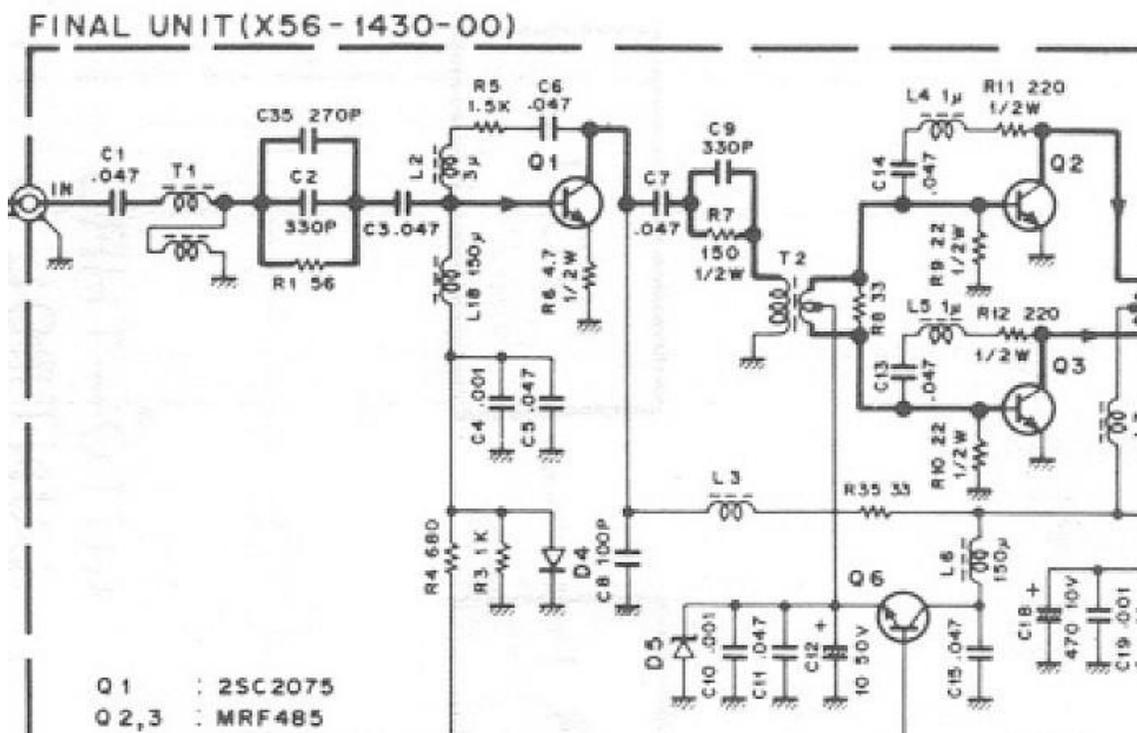
If you use the diode test function on a DMM to test the Base-Emitter and Base-Collector junctions on the drivers as diodes, the readings will be dramatically affected by the associated sub-components, especially the RF transformers. An almost dead short will appear between the emitter of the driver bias regulator Q6 and ground, and it will also be across the Emitter-Base leads on both drivers. None of my PA's show the exact same reading, but 12-13 ohms is typical. The schematic below shows why. Bias regulator Q6's emitter, along with D5, C10, C11, and C12 are connected to the center-tap on the secondary of RF transformer T2. And the ends of T2's secondary are connected to the bases of Q2 and Q3. Since the emitters are grounded, and T2's secondary is grounded on one end through a 22-ohm resistor, the circuit appears to be almost shorted.

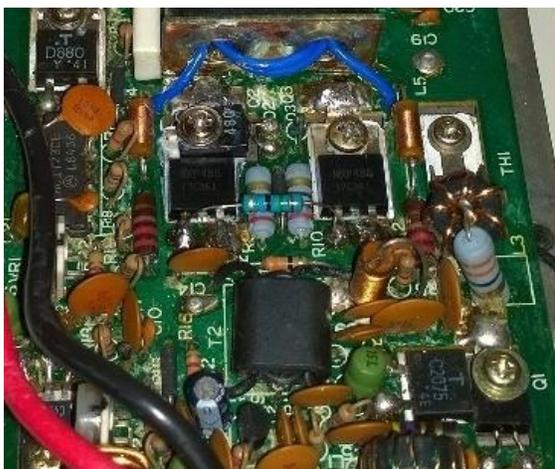
"PINNED"

2. **TO PIN OR NOT TO PIN.** When you take your PA out of your radio and begin to remove the drivers, you will notice that driver Q2 has a "20B" thermistor pushed down onto the tab screw, covered with thermal paste. The thermistor has a U-shaped end so it *could* be pinned down to the tab, but it's not. There's a second thermistor at regulator Q1, but that one IS pinned down. Pinning it down should result in better thermal transfer. So why didn't Kenwood do it for Q2 also? Who knows, but the screw at Q2 isn't long enough anyway.

Dave Phillips and I kicked this around, and we both have adopted the practice of installing a longer screw, and pinning the thermistor down. But that's more work, and you can't crank down on that screw. Look at the pictures below. The option is yours. I just thought I should mention it.

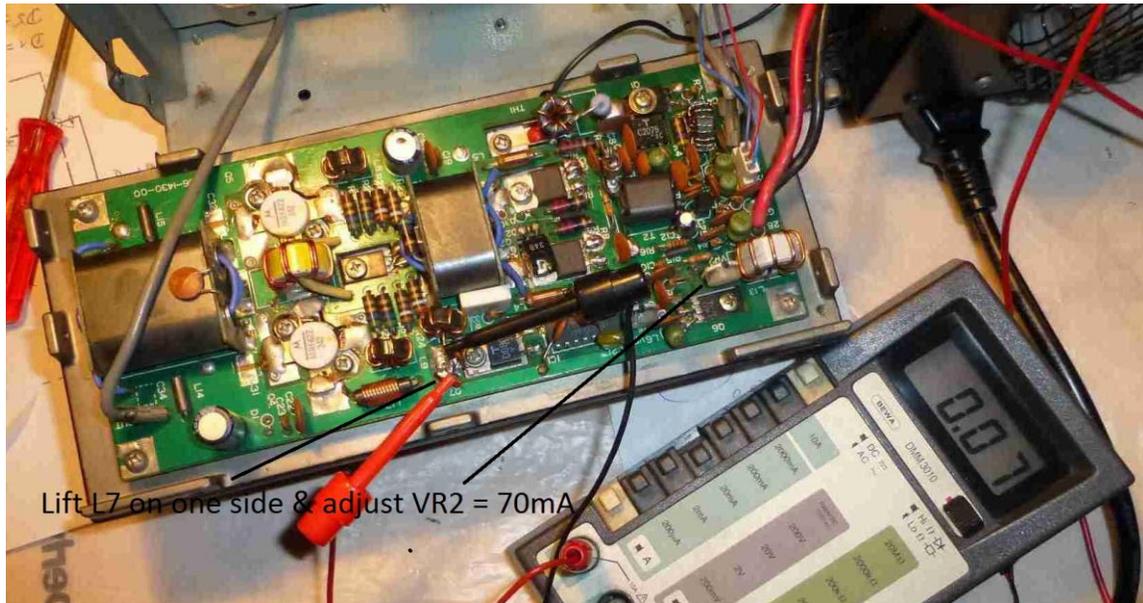
“After delivering 40V to the PA not only are the MRF’s blown, but most of the time the Zeners D1 and D5 are shorted, remove them but you don’t need to replace them due to the self protection function of the new Quint power supply.

John told me: since I adjusted my PA idle current = 70mA, I haven’t experienced the "flickering" dial light phenomenon that he mentioned in his earlier paper.”

Note how Marcel lifted the side of L7 near the regulator to set the idle current. Extreme care needs to be taken here not to short anything out.. The main idle current measurement shown below is much easier.

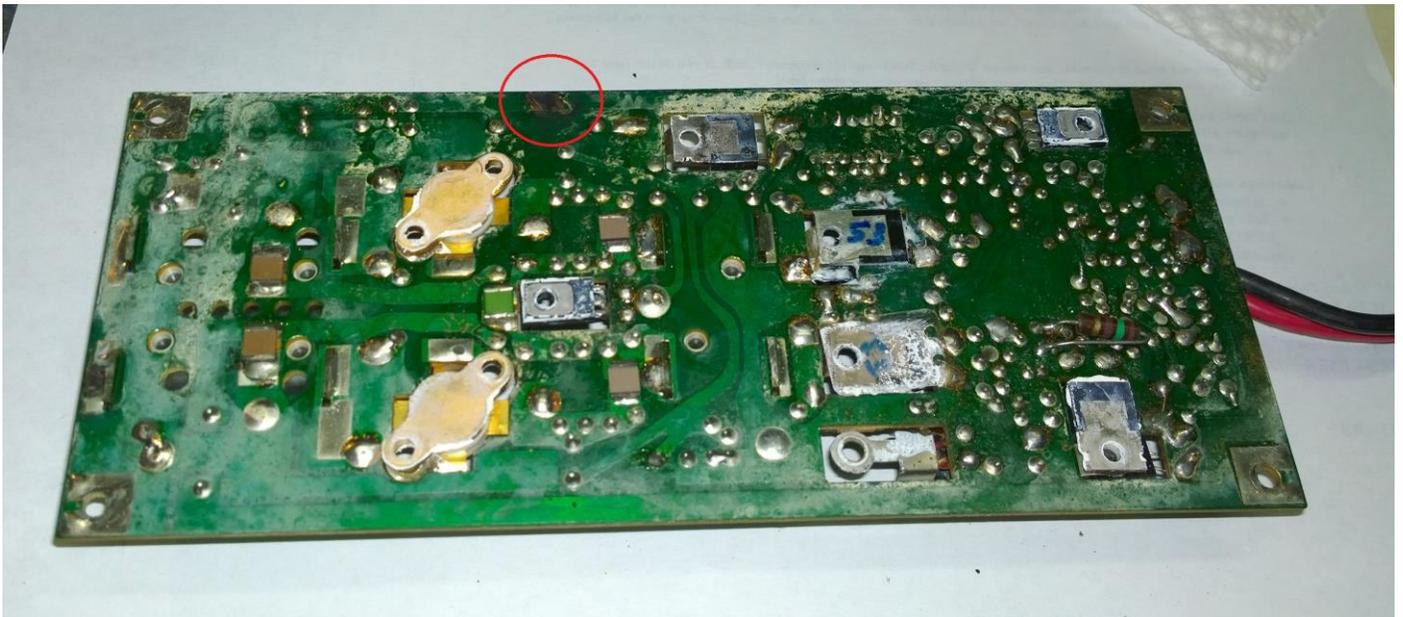
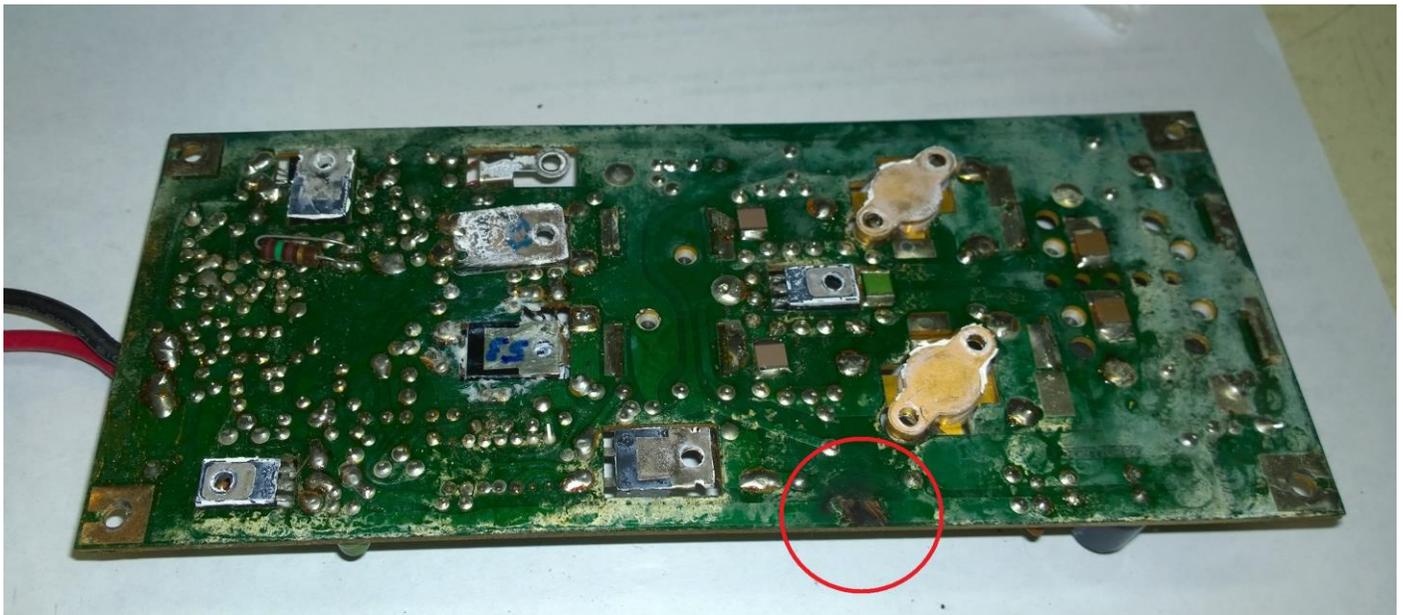
In Option 2, I show a way to use higher-gain MRF485 drivers without removing your PA board. The unit you see in that section is one of my spares. It has worked very well, and I've even used it as a "loaner" while I repaired someone's PA. But I recently decided to modify it to Option 3, using fairly high-gain (80) MRF485's from Eleflow. But when I removed the board to change the feedback loop resistors, I got a rude surprise! This is what I found.

This was one of the worst boards I've ever seen, and I've seen some bad ones. What's worse, I WAS USING IT. It had obviously suffered a major short as evidenced by the burned and repaired B+ foil. When I bought this PA on eBay, it worked great once I replaced the drivers, so I never tore it down. The underside looks like someone dropped it in salt water, wiped it off, repaired that foil, and then sold it online.

Removing your circuit board is not really that difficult, so unless you are SURE that your board is clean underneath, I recommend pulling it (see next page) and inspecting all solder joints and foil traces.

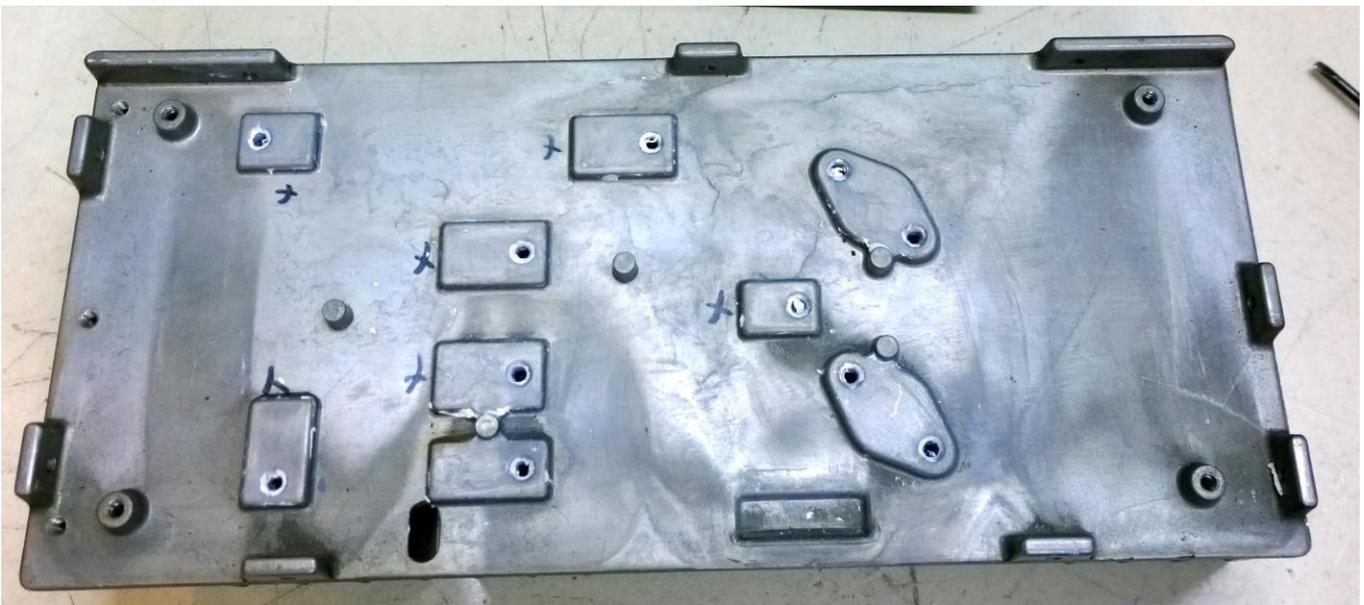
The "X's" below mark the insulator locations. The output "pills" mount right to the heat sink.
